SERVICE BULLETIN

DATE:	SEPTEMBER 30, 1992	SERVICE BULLETIN #	1521	# OF PAGES:	2
SUBJECT:	RESERVE CONTAINER BARTACKS TALON P/N 4111-() & TELESIS P/N 4113-()				
STATUS:	MANDATORY

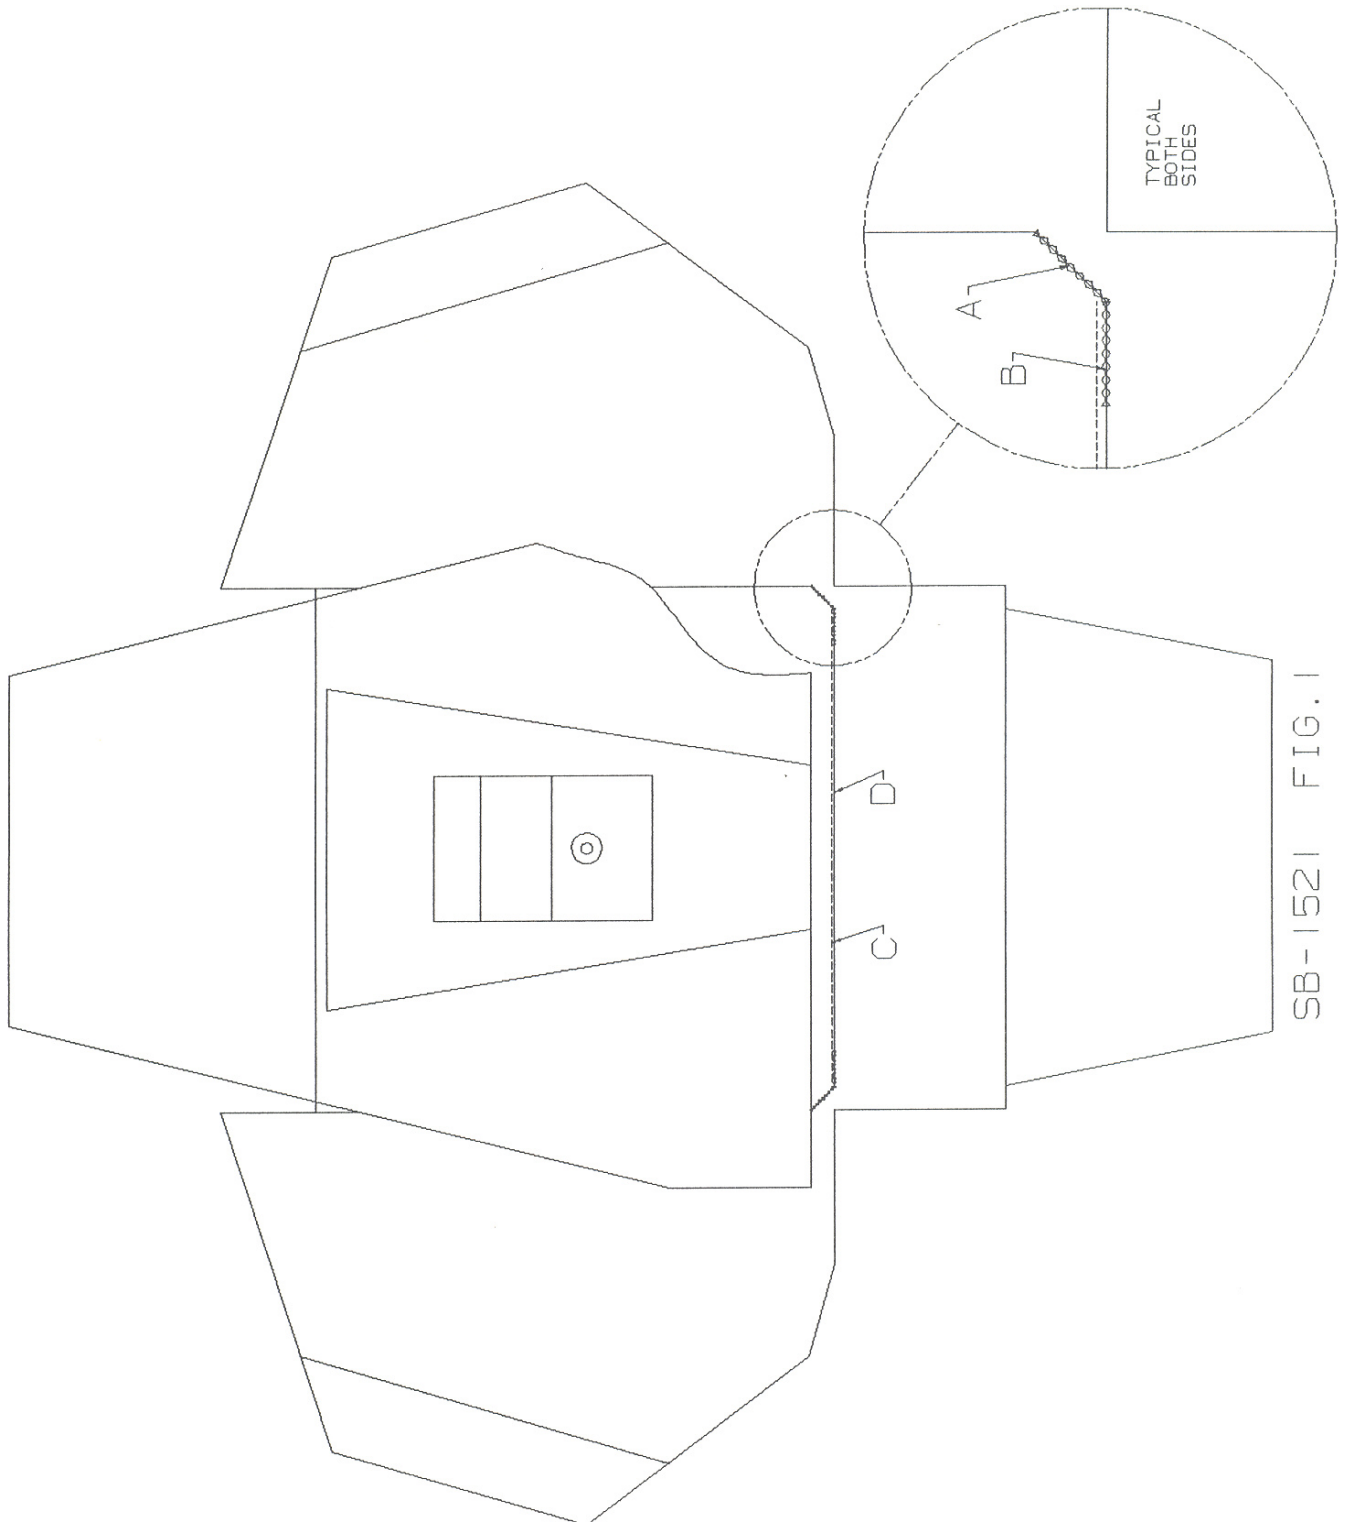
BACKGROUND: A number of Telesis and possibly Talon container systems have gone through production missing one or two reinforcing bartacks at the bottom corners of the reserve containers. Under rough usage, the reserve container may come free from the main container assembly. Because we are unable to determine how these missing bartacks went undetected and because we are unable to state with certainty that there are no other assemblies missing these bartacks, all affected assemblies must be inspected as soon as possible but no later than at the next repack cycle.

SERVICE BULLETIN: Inspect the lower inside corners of the reserve containers. See Fig. 1 for location of bartack. On earlier systems there was one bartack at each lower corner. (FIG 1-A) On later models there were two at each corner. (FIG. A&B) If the bartacks are in place, the assembly may be returned to service. If they are missing, the assembly is grounded until the container is modified according to Rigging Innovations Product Modification Procedure # 1235.
