SERVICE BULLETIN

DATE: August 29, 2007 **SERVICE BULLETIN #** SB-1544 **# OF PAGES:** 2

SUBJECT: Aviator container side gusset Velcro modification

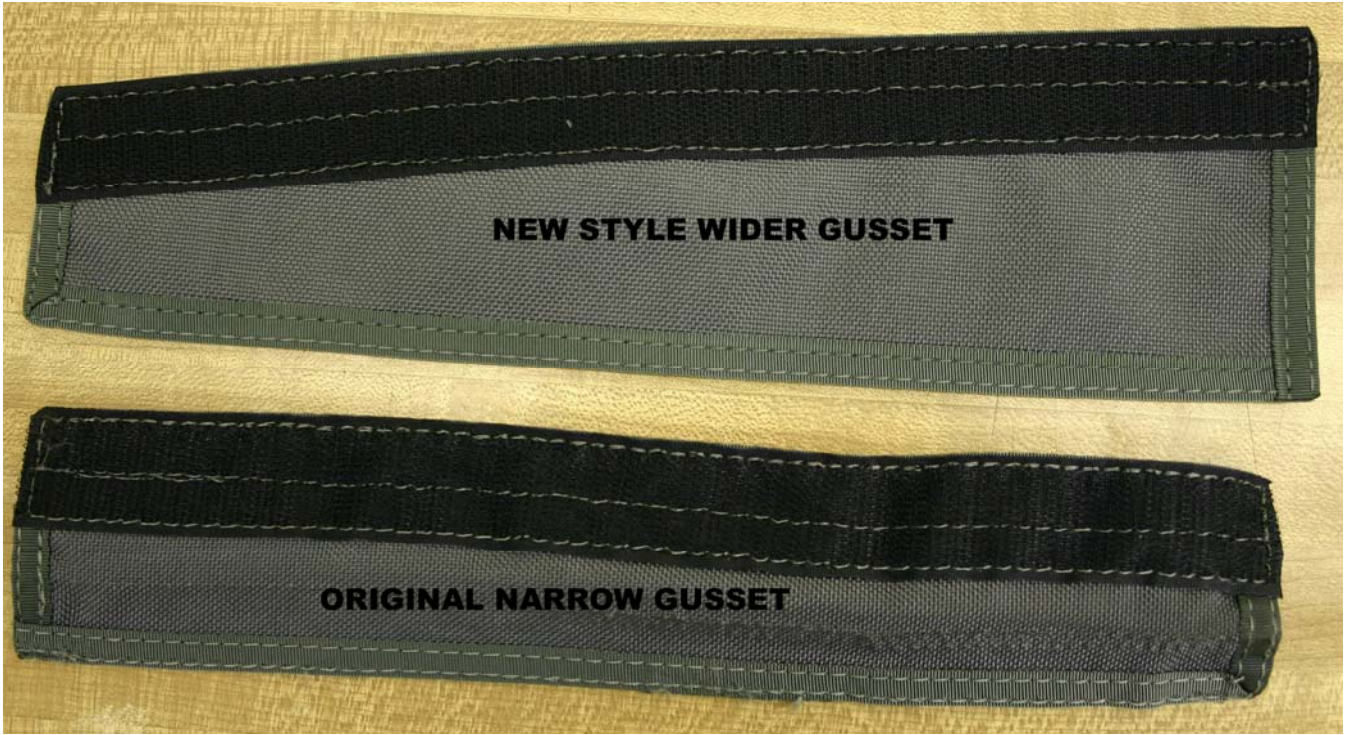
FIGURE 1

BACKGROUND: The early model Aviators of the above sizes had a narrow side gusset (Figure 1). It has been identified that during wearing and use, the horizontal back strap pulls on the side gusset and may open the Velcro closure exposing the inner deployment bag.

SERVICE BULLETIN: The side gusset panel is replaced with a wider and tapered shape that relieves the loading on the container during use (Figure 1). This precludes the container Velcro from opening during wearing and use. This modification should be done in compliance with RI Product Modification Procedure PMP-1262.
