SERVICE BULLETIN

DATE: JULY 18, 2000 **SERVICE BULLETIN #** SB-1538 **# OF PAGES:** 2
SUBJECT: MAIN RISERS
STATUS: RECOMMENDED

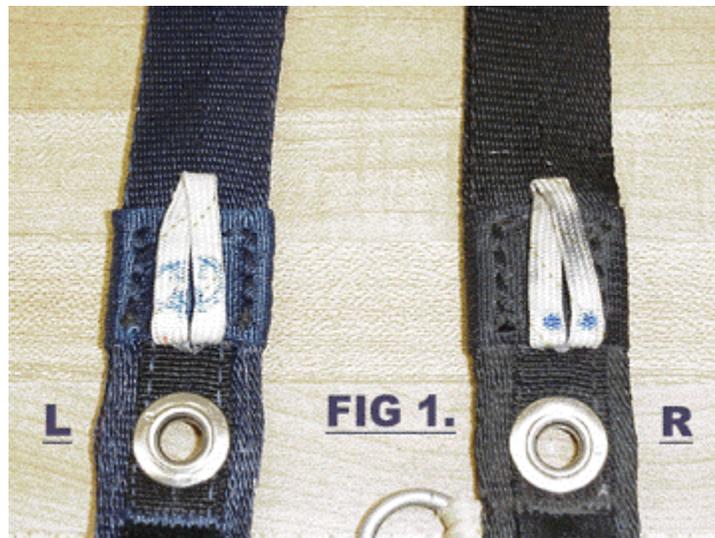
- d. If the loop holds, mark the rear side of the loop with two dots of a BLUE permanent marker (Fig. 1R). The riser may then be returned to service. Check to make sure no damage was done to the loop during the test.
4. All new risers manufactured after January 2000 will have an identifying QC stamp on the rear of the locking loop as in Fig. 1L and do not need to be checked and are not subject to this Service Bulletin.

1. Since the subject risers are a non-certified separate component, this part does not have any identifying part number or date of manufacture. The only marks are L & R on the rear of the respective riser.
2. It must be assumed that any riser installed on a Rigging Innovations product has been manufactured by Rigging Innovations and consequently needs to be checked.
3. The locking loops need to be checked by doing the following:
 - a. Remove the risers from the main 3-ring.
 - b. Fasten the riser-locking loop around a smooth hook or similar object anchored securely and that will not damage the loop material.
 - c. Apply approximately 40 lbs of tension to the loop for 3 seconds. The force must be applied along the plane of the risers in the direction of the rings. If the bartacks are

missing, the end of the loop will pull free. The risers must then be returned to the manufacturer for repair.
